## When Kildwick Church nearly fell down – and what was done to save it

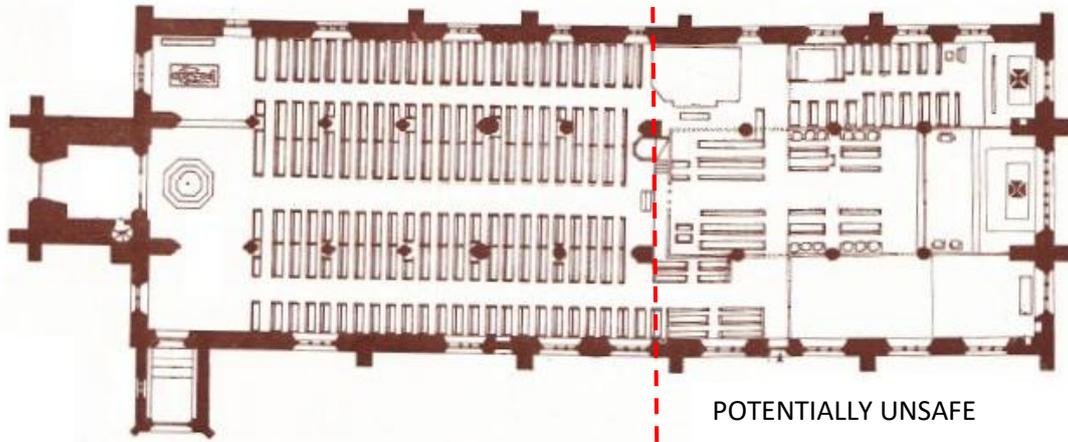
Area of the church thought unsafe – as of May 1897

Mr Peterson, architect, Bradford, reported upon a recent examination of the fabric. He stated that three bays of the choir were 6in. out of the perpendicular. The centre pillar of the south aisle was considerably damaged, and this fixture was not only insecure in itself and dangerous to the public, but was also an eyesore. He considered that the north and south arcades should be rebuilt, and that the roof of the church should be reslated. He estimated the cost at about £1200.—The Vicar said that they believed the total alterations needed would mean an outlay of about £1400 or £1500.—Mr F P Peacock, a warden, said that they had no funds with which to face the outlay, and were, in fact, £20 in arrear at the end of the last financial year.

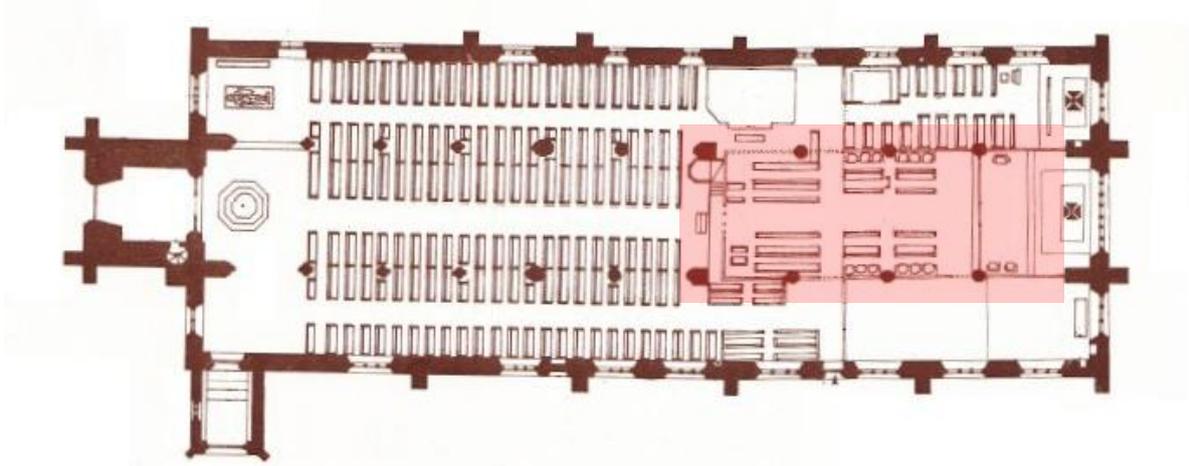
This extended the area requiring attention further west than the original plan and a recommendation was made for the immediate propping-up of the pillar to the west of the organ. The cost of the restoration work would increase by 20%.

**Area of the church thought to require attention (shaded) – as of December 1899**

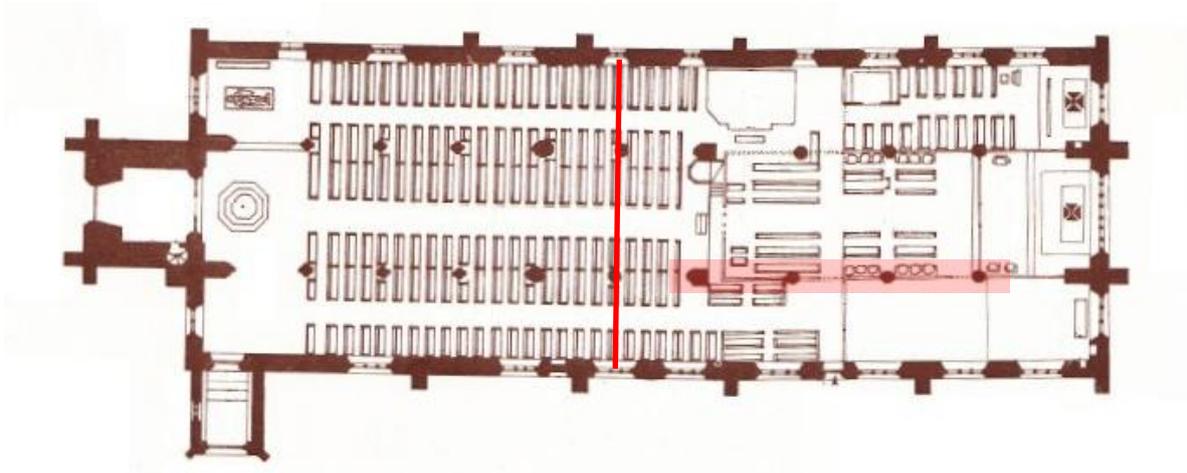
**Location of the protective partition (red) – 25/11/1901 to 20/9/1902  
and the work carried out in December 1901 and January 1902 (shaded)**

On December 2nd, the plaster was stripped off the four arches and pillars on the south side that had been previously been propped – shown shaded above. Cracks were found in a number of the pillars and arches, with one pillar cracked diagonally almost from top to bottom.

The reason why the pillars were leaning towards the south was also found. None of them had foundations and had been erected on the surface of the soil, or only a few inches beneath, and over graves which had subsequently collapsed.

All four pillars and arches, and the wall above that the arches supported were demolished. It was during this work that the wall above the arches would found to contain blocks of stone with carved scroll-work, later identified as being fragments of Saxon (actually Anglo-Danish) crosses dating from around 950AD.

New foundations were dug for all four pillars, to a depth of six feet, and filled with concrete.

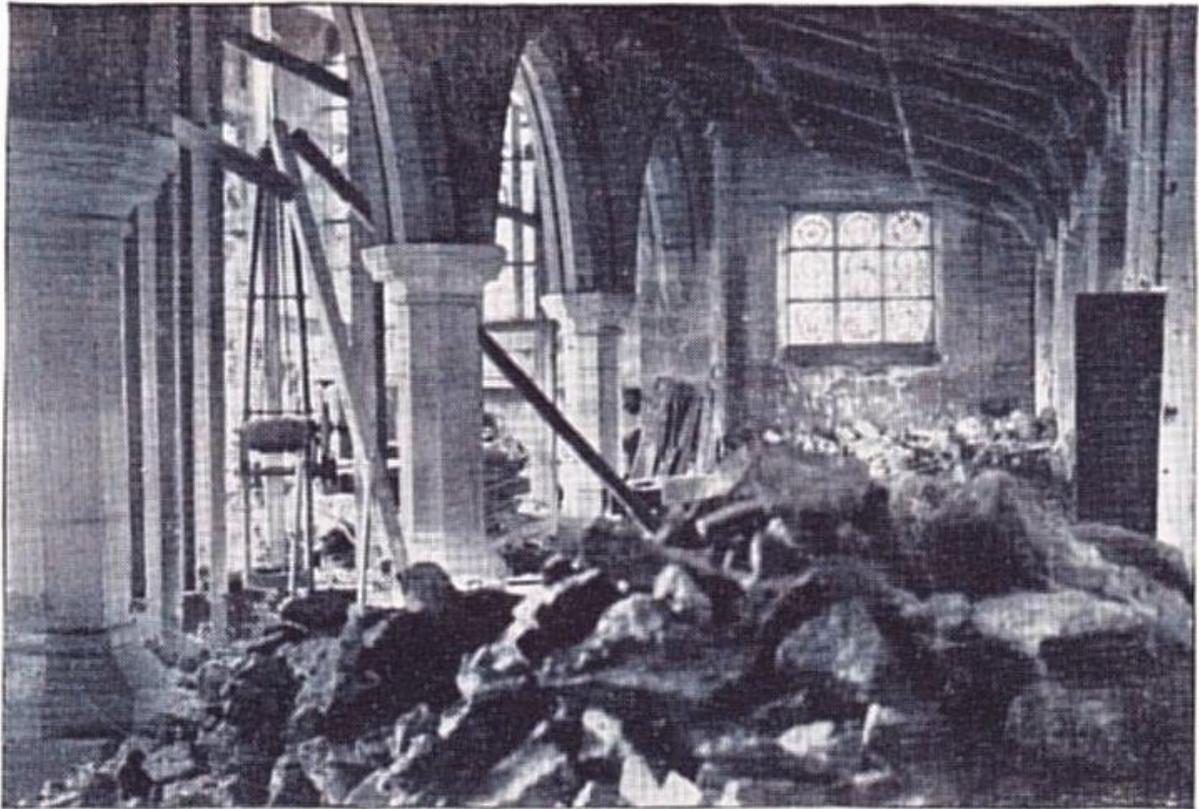
**Three of the four rebuilt pillars and arches at the south-east of the church**

Once the foundation stones were laid the pillars, arches and wall was rebuilt using the old stones where possible and new stones where the old ones could not be re-used.

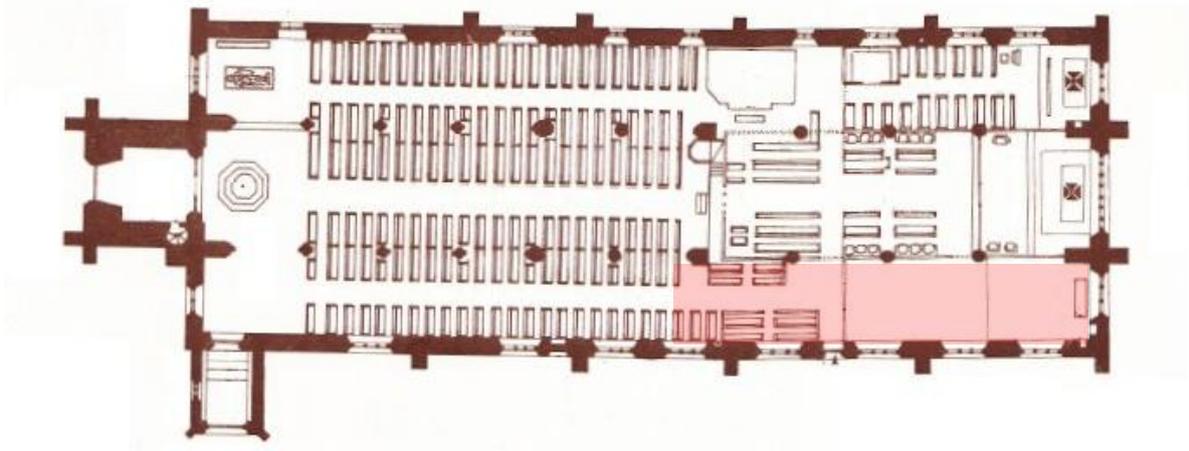
**Location of the work carried out on the roof and inside of the south wall  
in February and March 1902 (shaded)**

It was found that the spars holding up the roof of the single-storey south aisle were rotten and needed to be replaced.

This work involved removing the existing plaster on the inside of the south wall. It had been hoped to then just re-point the stonework, however it was found that the size and quality of the stones did not allow re-pointing, and the wall would need to be re-plastered.

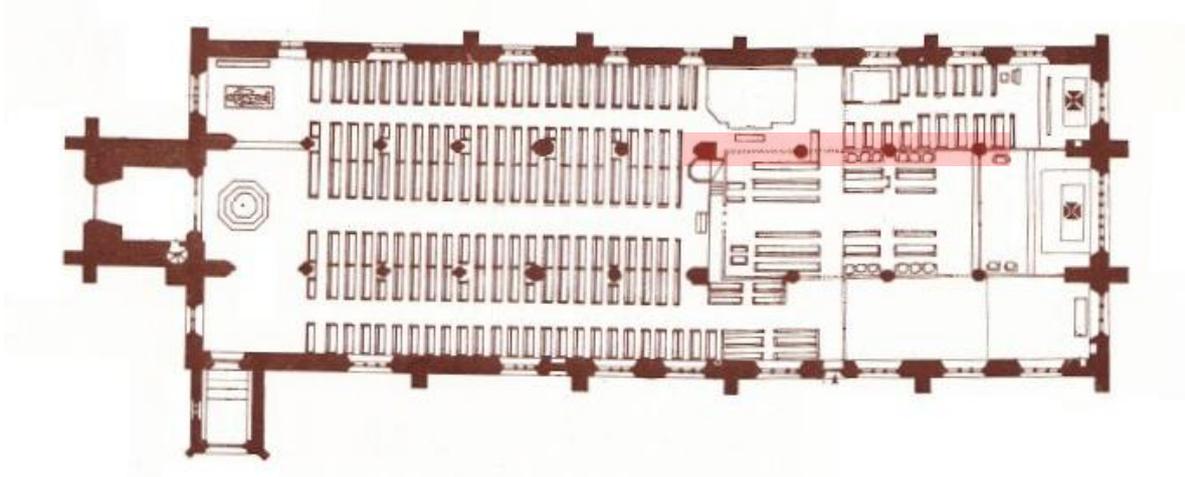
**Location of work carried out on the north side pillars  
in March and April 1902 (shaded)**

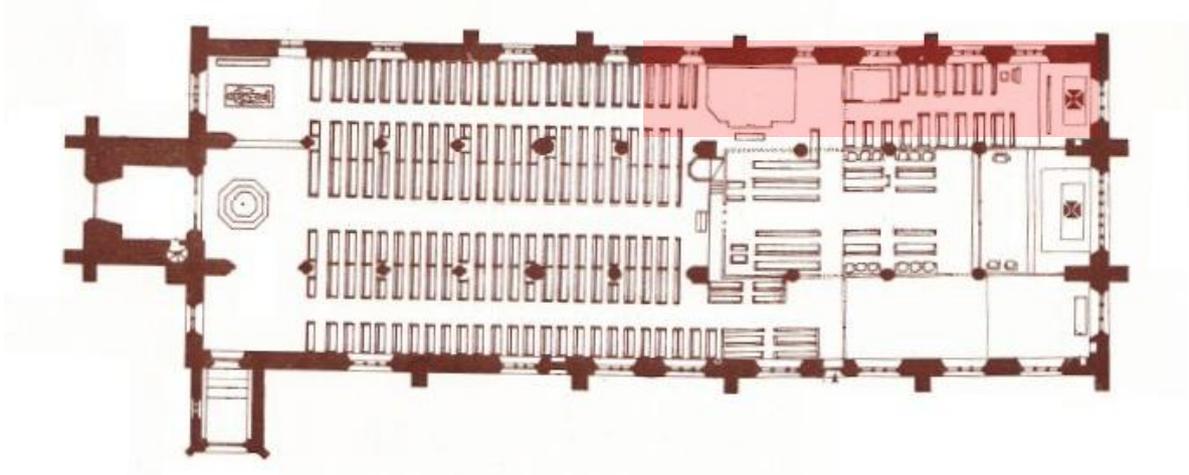
This reordering of the chapel turned out to be rather fortuitous as it was quickly found that part of the north wall of the chapel – the exterior wall of the building – was leaning inwards.

**Location of work carried out on the north side of the building during May and June 1902 (shaded)**

The roof was removed and the external wall taken down. Here again it was found that this wall had no foundations, having been built directly on the ground surface.

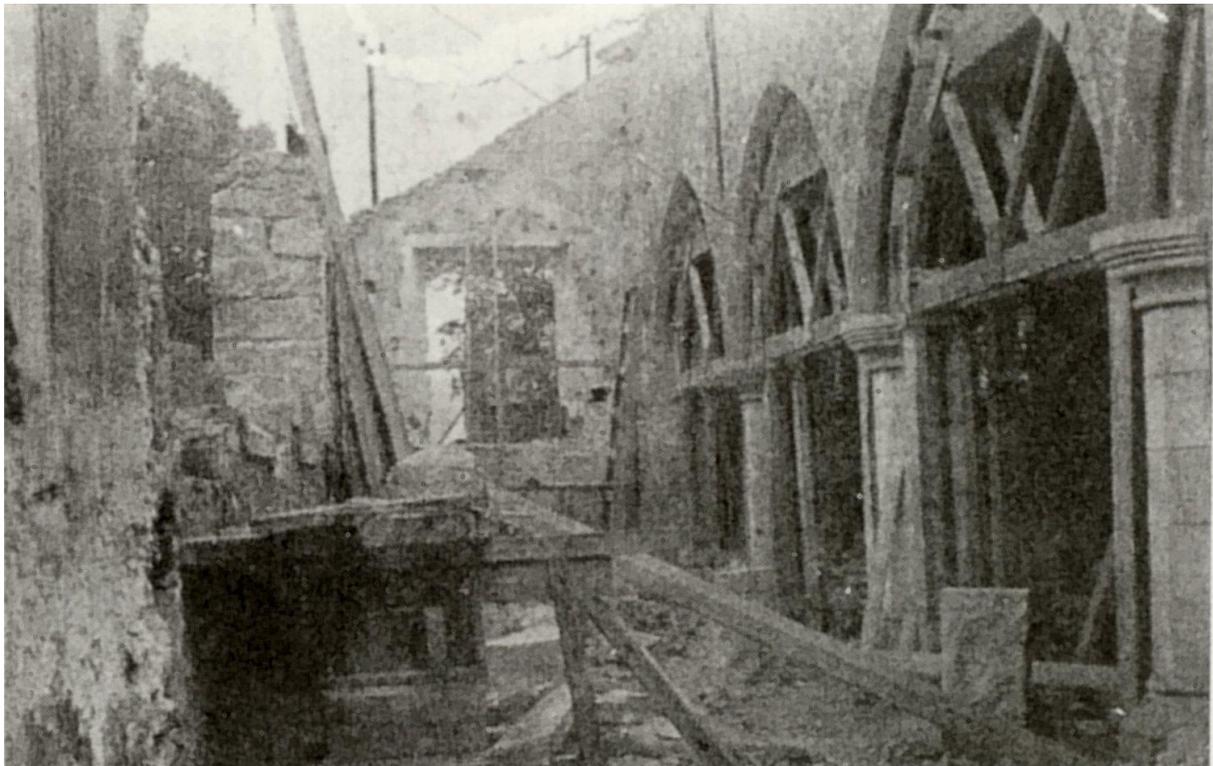
**Curren Chapel, looking east, without a roof and with part of the north wall taken down (June 1902)**

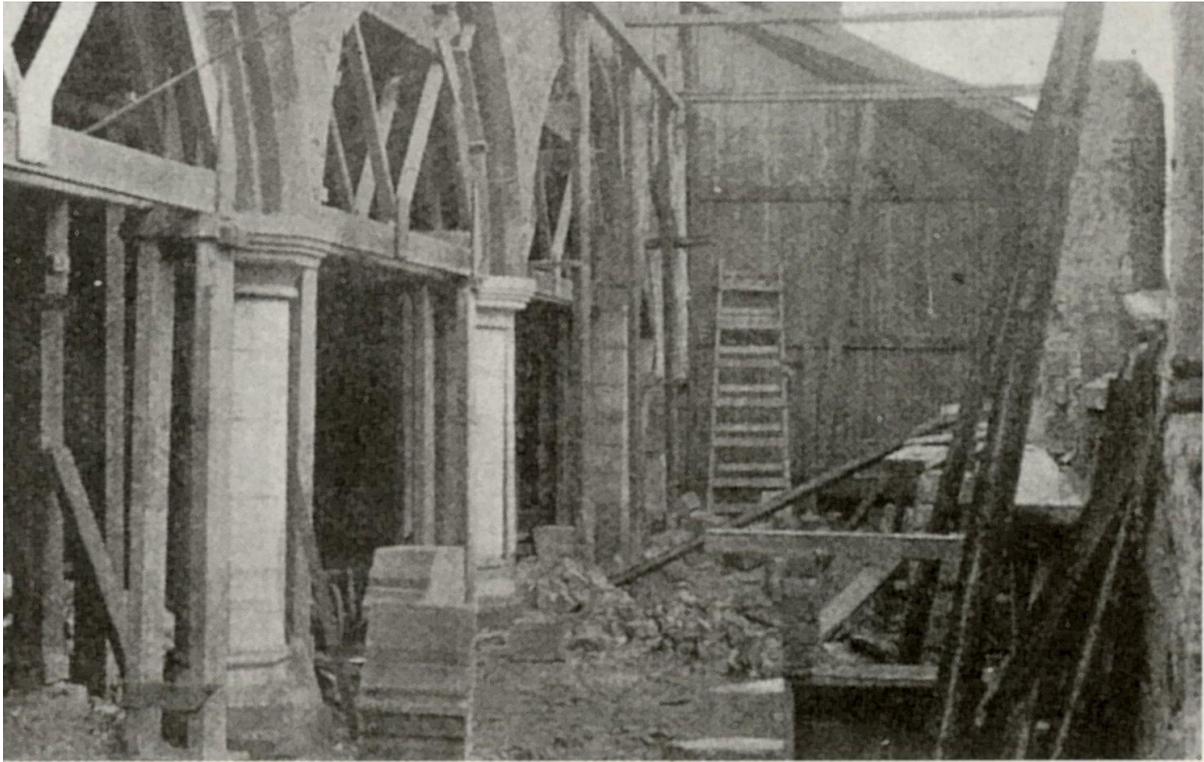
**Work in progress on the north side of the building, looking west.  
The back of the partition built across the church can be seen.**

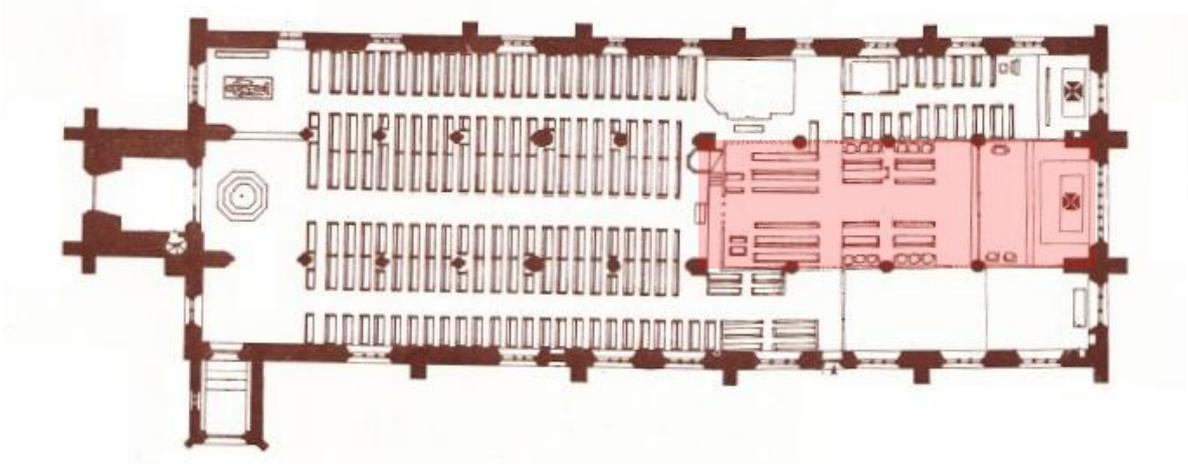
**The re-positioning of the central section of the roof on the rebuilt pillars and arches (July 1902)**

Work on the pillars and arches had corrected their lean to the south and made them perpendicular. During this work the roof of the central section had been held up with props. It was now time to realign the roof and fix it to the newly repaired walls.

This required careful levering of the roof into a position approximately a foot to the north of its previous location. This delicate process took two days and was achieved without removing any of the slates.

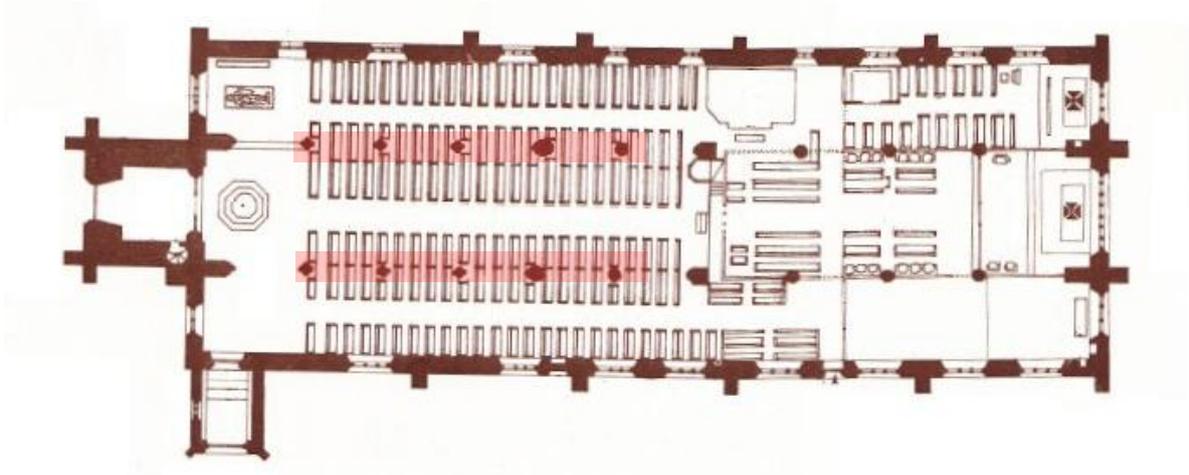
**Location of work carried out on the pillars of the west end during Autumn and Winter 1902 (shaded)**

Removal of the plaster showed the poor condition of many of the pillars:

- North side, pillar four (from west end): built largely from rubble
- South side, pillar four: ditto
- North side, pillar five: missing most of the base, which had been cut-away

In the end it was decided to take down and rebuild all the pillars except the second and third from the west on the south side.

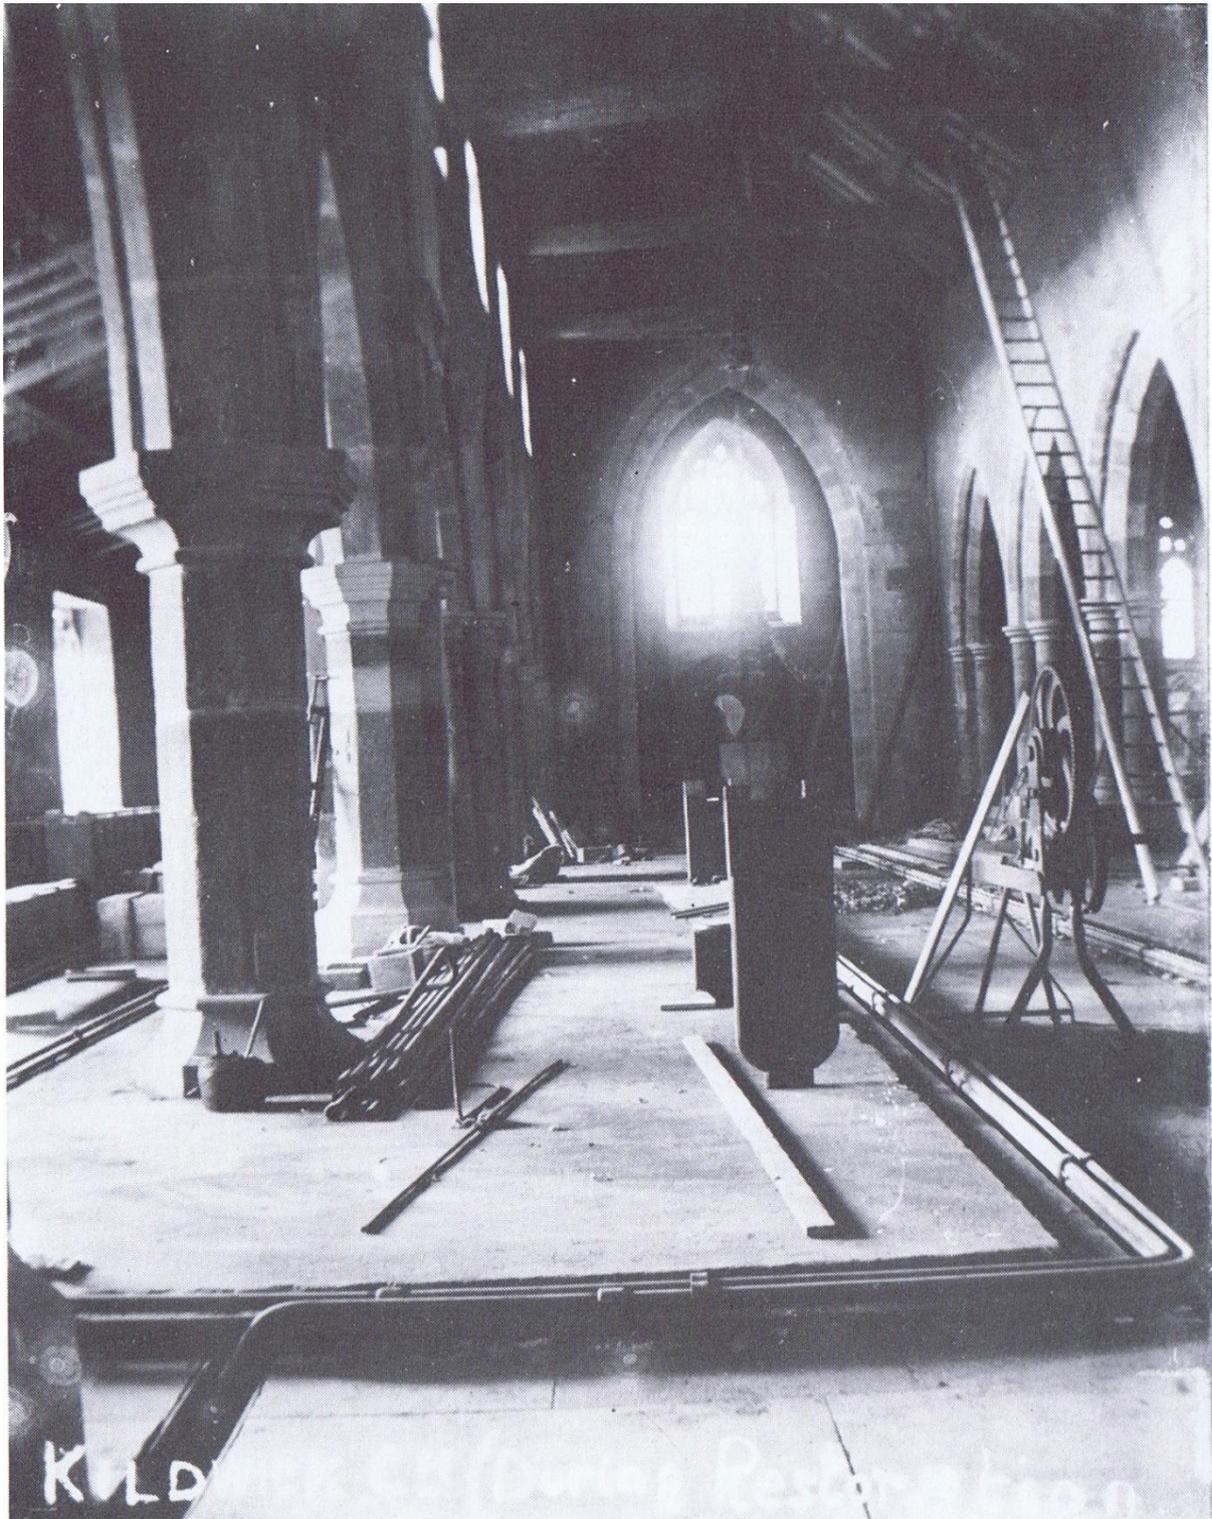
**Work in progress at the west end of the church (Autumn/Winter 1902  
Notice the opened-up west end of the church, all the pipe-work, and the new masonry**
