What happened to the early Norman Church in Kildwick ?

Introduction

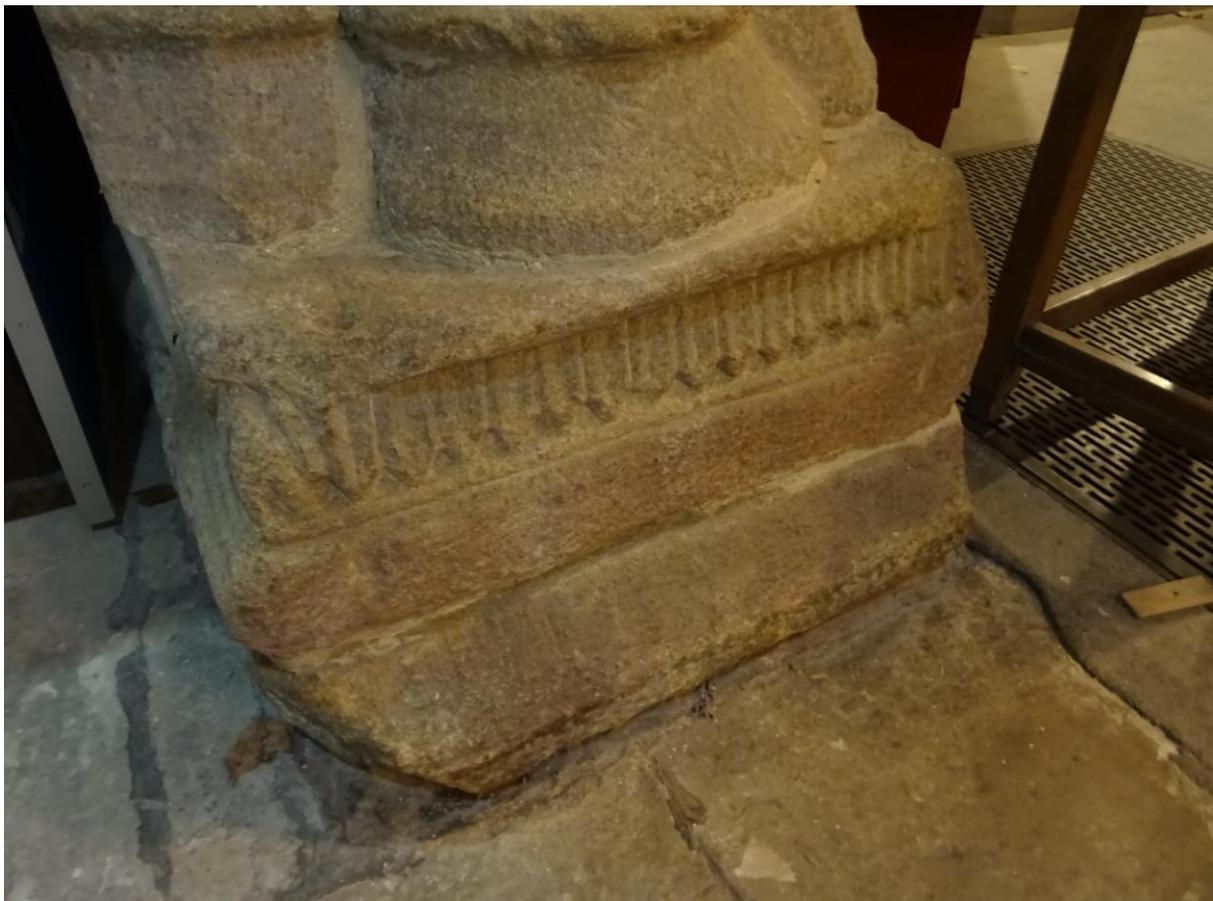
All that remains are the tops (the capitals) of two columns which have been incorporated into the early-1300s building by turning them upside-down and using them as columns bases. Their locations are indicated in red on the plan of the church shown earlier.

The base of the column at the very west end of the church

Note: *The base of the column at the very west end of the church is quite easily seen; the base of the 4th column is more difficult as it is largely below the level of the wooden platform that supports the pews. Both have the same decoration.*

These inverted capitals are of good quality and are sizeable pieces of masonry – one slightly smaller than 30” square, the other slightly larger – and surely indicate that the Norman structure was a substantial building.

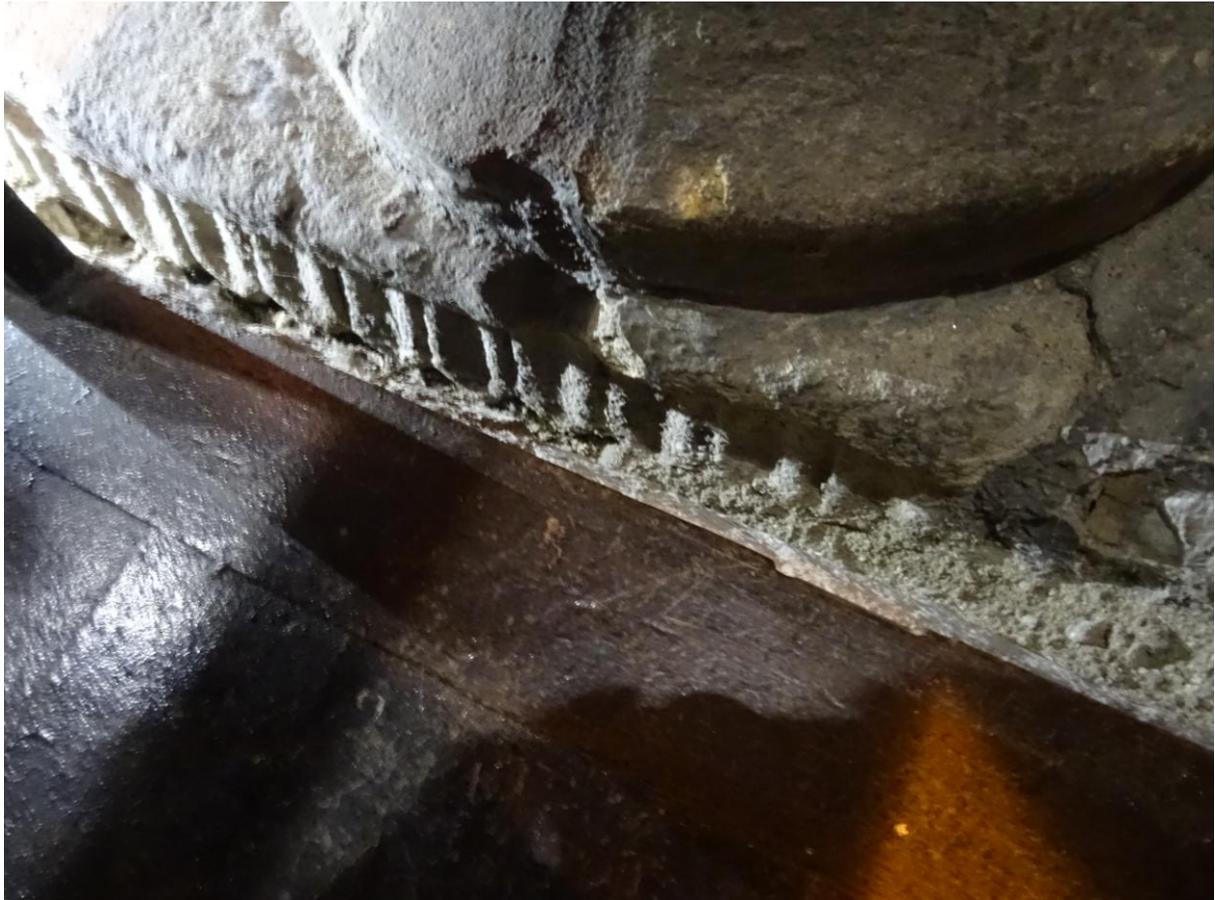
The base of the 4th column from the west end (with thanks to Chris Wright)
